SERVICE BULLETIN

Description: Loud Speaker 300/600W External	
Service Manual: ASM-LS	Service Bulletin No.: ASM-LS-603-0003
ECO No.: ECO# 1180	Subject: Bell Stop Drill Procedure

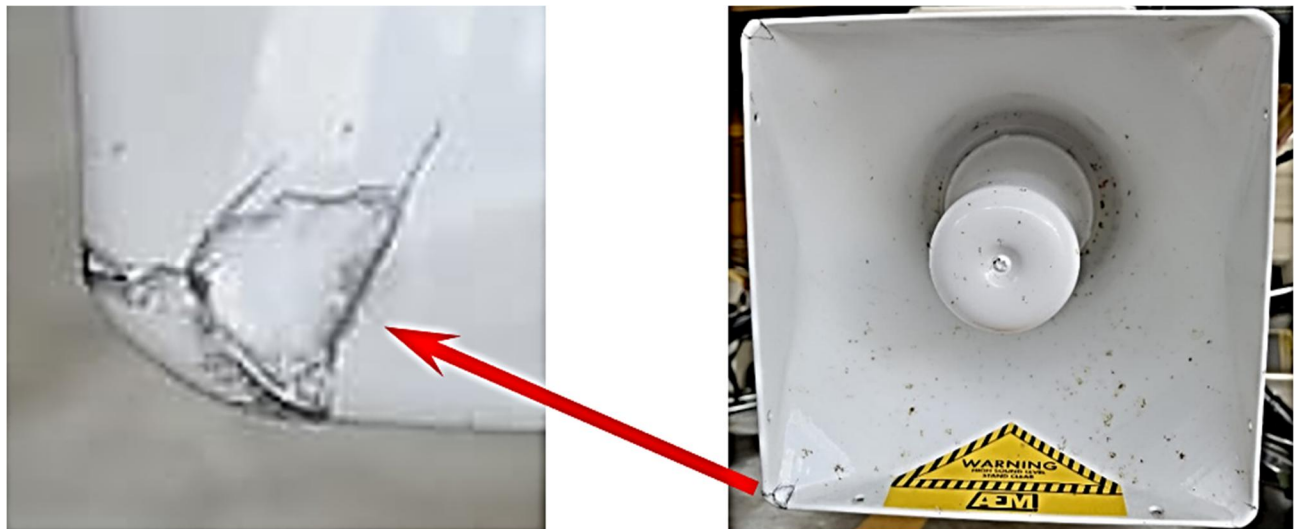
Figure 1 - Cracked Bell

1.3.1 AEM has identified that a suspect manufacturing process resulted in defects on some LSxxx products. This manufacturing process issue has now been corrected. AEM received a report of a speaker bell which cracked during service, shown in Figure 1. This service bulletin details stop drill repair and visual inspection requirements for continued airworthiness prior to replacement of bells with a crack. Stop drilling is a temporary measure to deal with time constraints of obtaining replacement bells, the permanent fix is to replace the cracked bells.

2.1.1 Inspect the bell for flaws, example crack suitable for stop drill repair shown below in Figure 1.

1.4.1 AEM recommends bells with any structure cracks are replaced. During the bell replacement process, to continue temporary airworthiness prior to bell replacement, follow this in field service bulletin repair procedure to stop drill bell cracks in one or more corners of cracked bells. If a bell is found to be cracked, perform the stop drill repair, and AEM recommends inspection be accomplished after every flight until bell replacement. After bell replacement, inspection is no longer required. Further maintenance of the LSxxx products is 'on condition' only.

- 2.1.2 To complete the following repair, the crack must be ≤ 2 inches long. If the crack is > 2 inches, the bell must be replaced and cannot be repaired with a stop drill. See service bulletin ASM-LS-603-0004 for bell replacement.
- 2.1.3 Remove and discard any loose material, or material suspected to become loose as shown in Figure 2.
- 2.1.4 Locate the tip of the crack by unaided visual inspection. Drill a 0.1 inch diameter hole beyond the visible crack tip in the path of the crack as shown in Figure 3.
