SERVICE BULLETIN - OPTIONAL

Part No.: MTP136D-000GN

Description: Mission Transceiver Panel Mount	
Service Manual: N/A	Service Bulletin No.: MTP136D-000GN-603-0002
ECO No.: ECO1220	Subject: Optional 1.02 Firmware Update

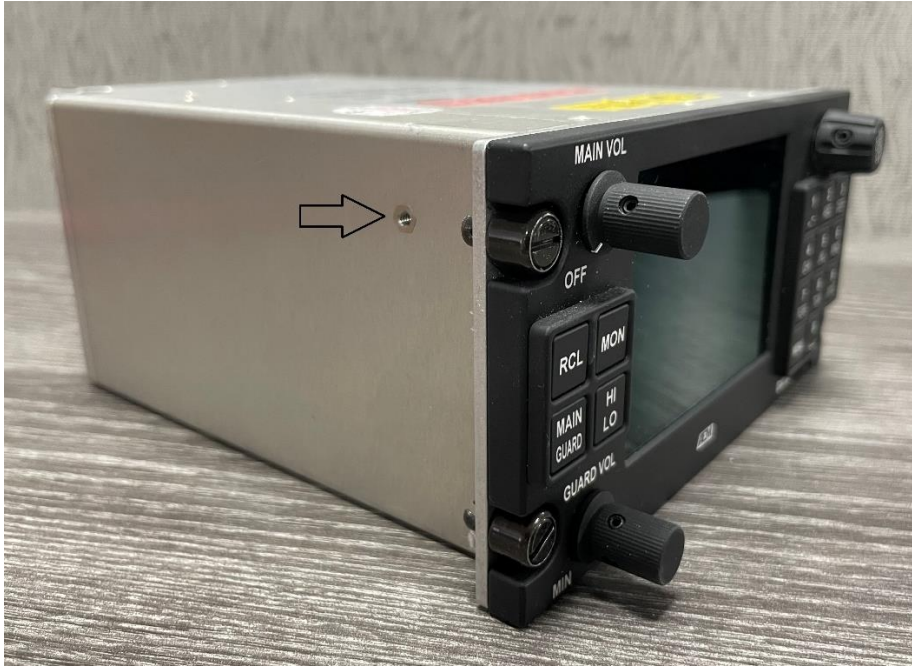
#	Procedure	Completed
1.	Power off the MTP136D by rotating MAIN VOL counterclockwise into the detent	
2.	Unfasten the MTP136D from the instrument panel and slide it out until the small opening on the left side of the chassis can be easily accessed.

3.	Use a pin, pick, or small screwdriver to press and hold the button inside the opening.	
4.	While holding the button, power on the MTP136D by rotating MAIN VOL clockwise past the detent.	
5.	Release the button. The screen will be blank indicating the MTP136D is in USB Bootloader mode.	
6.	Open a web browser and navigate to the AEM Radio Firmware Programmer located at www.aem-corp.com on the MTP136D product page under software.	
7.	Follow the instructions to program (restore) the original firmware version. Driver installation with administrator access is required for first time use.
