## SERVICE BULLETIN - OPTIONAL

Part No.: LS300-20x Loudspeakers

Service Bulletin No.: ASM-LS-603-0006

Subject: Re-entrant Tip Securing (MOD 4)

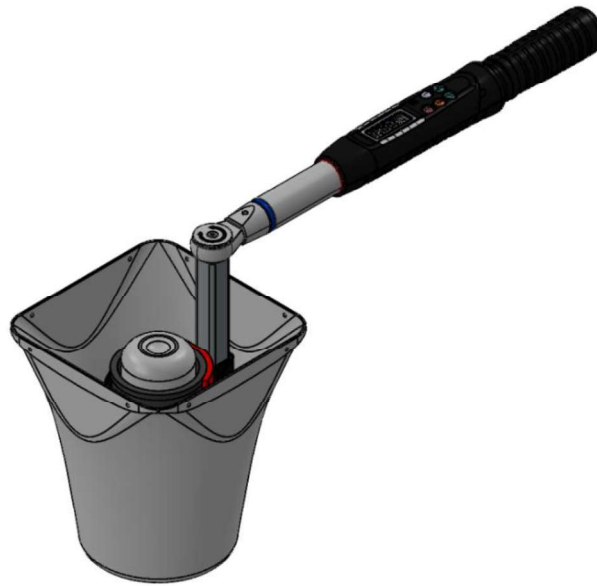
Figure 3 – Re-entrant Tip Removal with Torque Wrench

Note: For Loudspeakers with MOD 2, a Locking Tab may separate from the Doubler Plate during removal of the Re-entrant Tip. Ensure any tab debris is removed and discarded from the Speaker Assembly.

- 2.1.3 Insert Square Drive Size Adapter (3/8" Female x 1/2" Male) into Torque Wrench (3/8" Drive). Per Figure 3, insert Torque Wrench Assembly into Square Tube of Wrench Adapter Assembly (WA-001 and 156-99-005). Rotate Torque Wrench Assembly counterclockwise until slack in Strap of Wrench Adapter Assembly is removed. Continue rotating Torque Wrench Assembly counterclockwise to remove Re-entrant Tip. Remove the Re-entrant Tip carefully to ensure the fiber and rubber washers stay inside the Re-entrant Tip. If they do separate, insert the Fiber Washers first and last (Rubber Washers will be between both Fiber Washers). Inspect Re-entrant Tip for damage. Contact AEM for replacement Re-entrant Tip as required. Remove Torque Wrench Assembly from Wrench Adapter Assembly and set aside.

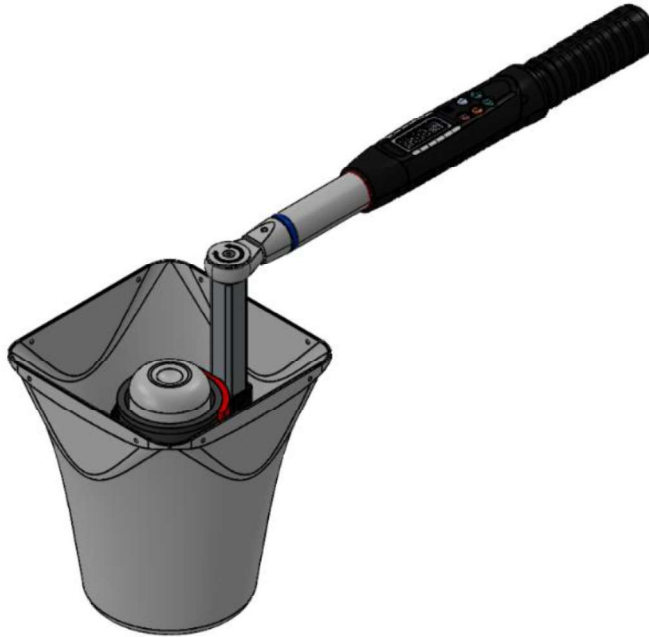
Figure 12 – Re-Entrant Tip Inspection with Torque Wrench Assembly

If Re-Entrant Tip does not begin to rotate, the inspection is complete.

If Re-Entrant Tip begins to rotate, reference Section 2 as required and contact AEM.

- 3.1.3 Insert Square Drive Size Adapter (3/8" Female x 1/2" Male) into Torque Wrench (3/8" Drive). Per Figure 12, insert Torque Wrench Assembly into Square Tube of Wrench Adapter Assembly (WA-001 and 156-99-005). Rotate Torque Wrench Assembly counterclockwise until slack in Strap of Wrench Adapter Assembly is removed. Continue rotating Torque Wrench Assembly until it reaches 100 in-lb. Do not exceed 120 in-lb.
