**SERVICE BULLETIN - OPTIONAL****Part No.: MTP136D-000GN**

| Description: <b>Mission Transceiver Panel Mount</b> | |
| Service Manual: <b>N/A</b> | Service Bulletin No.: <b>MTP136D-000GN-603-0003</b> |
| ECO No.: <b>ECO1238</b> | Subject: <b>Optional 1.03 Firmware Update</b> |

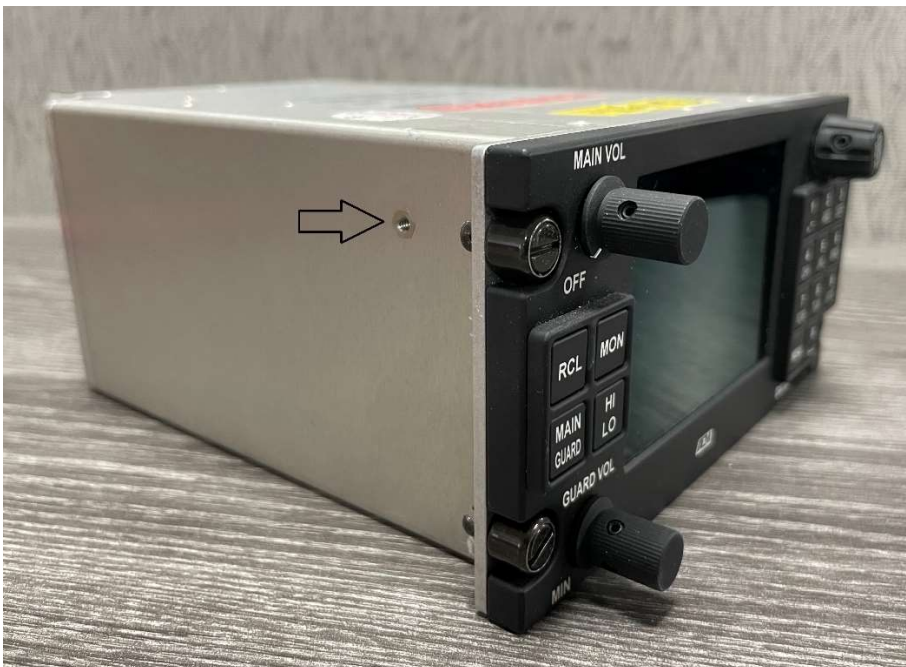
| # | Procedure | Completed |
|---|---|---|
| 2. | Unfasten the MTP136D from the instrument panel and slide it out until the small opening on the left side of the chassis can be easily accessed. | |

| 3. | Use a pin, pick, or small screwdriver to press and hold the button inside the opening. | |
