SERVICE BULLETIN - OPTIONAL

Part No.: MTP136D-000GN

Description: Mission Transceiver Panel Mount	
Service Manual: N/A	Service Bulletin No.: MTP136D-000GN-603-0004
ECO No.: ECO1262	Subject: Optional 1.10 Firmware Update

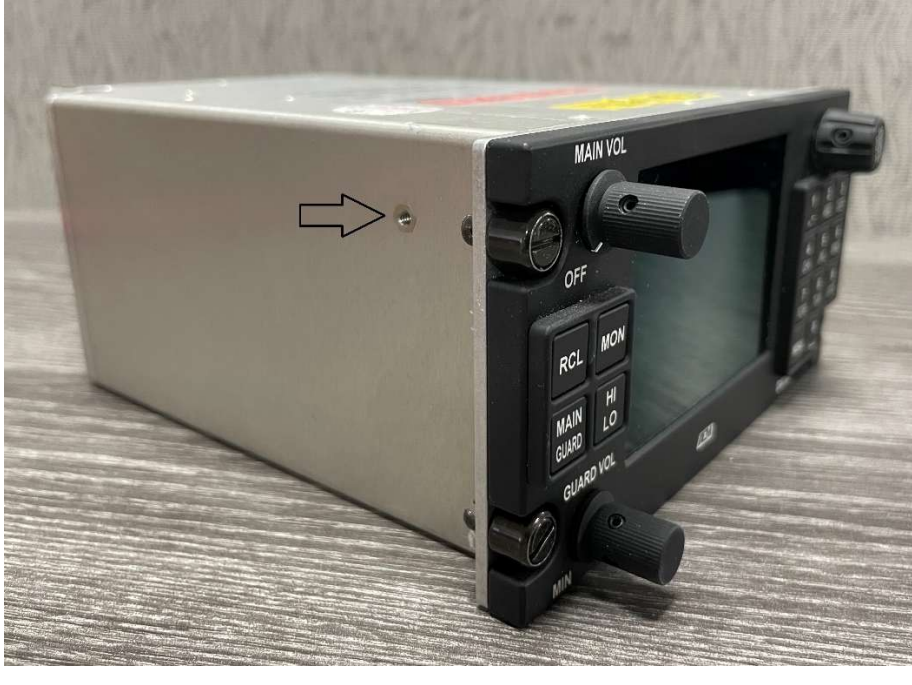
#	Procedure	Completed
1.	Power off the MTP136D by rotating MAIN VOL counterclockwise into the detent	
2.	Unfasten the MTP136D from the instrument panel and slide it out until the small opening on the left side of the chassis can be easily accessed.

3.	Use a pin, pick, or small screwdriver to press and hold the button inside the opening.	
4.	While holding the button, power on the MTP136D by rotating MAIN VOL clockwise past the detent.
